Tree Mitigation Example
 The Grove at Shoal Creek
 March 25, 2016

Tree Mitigation Example
 The Grove at Shoal Creek | 3.25.16

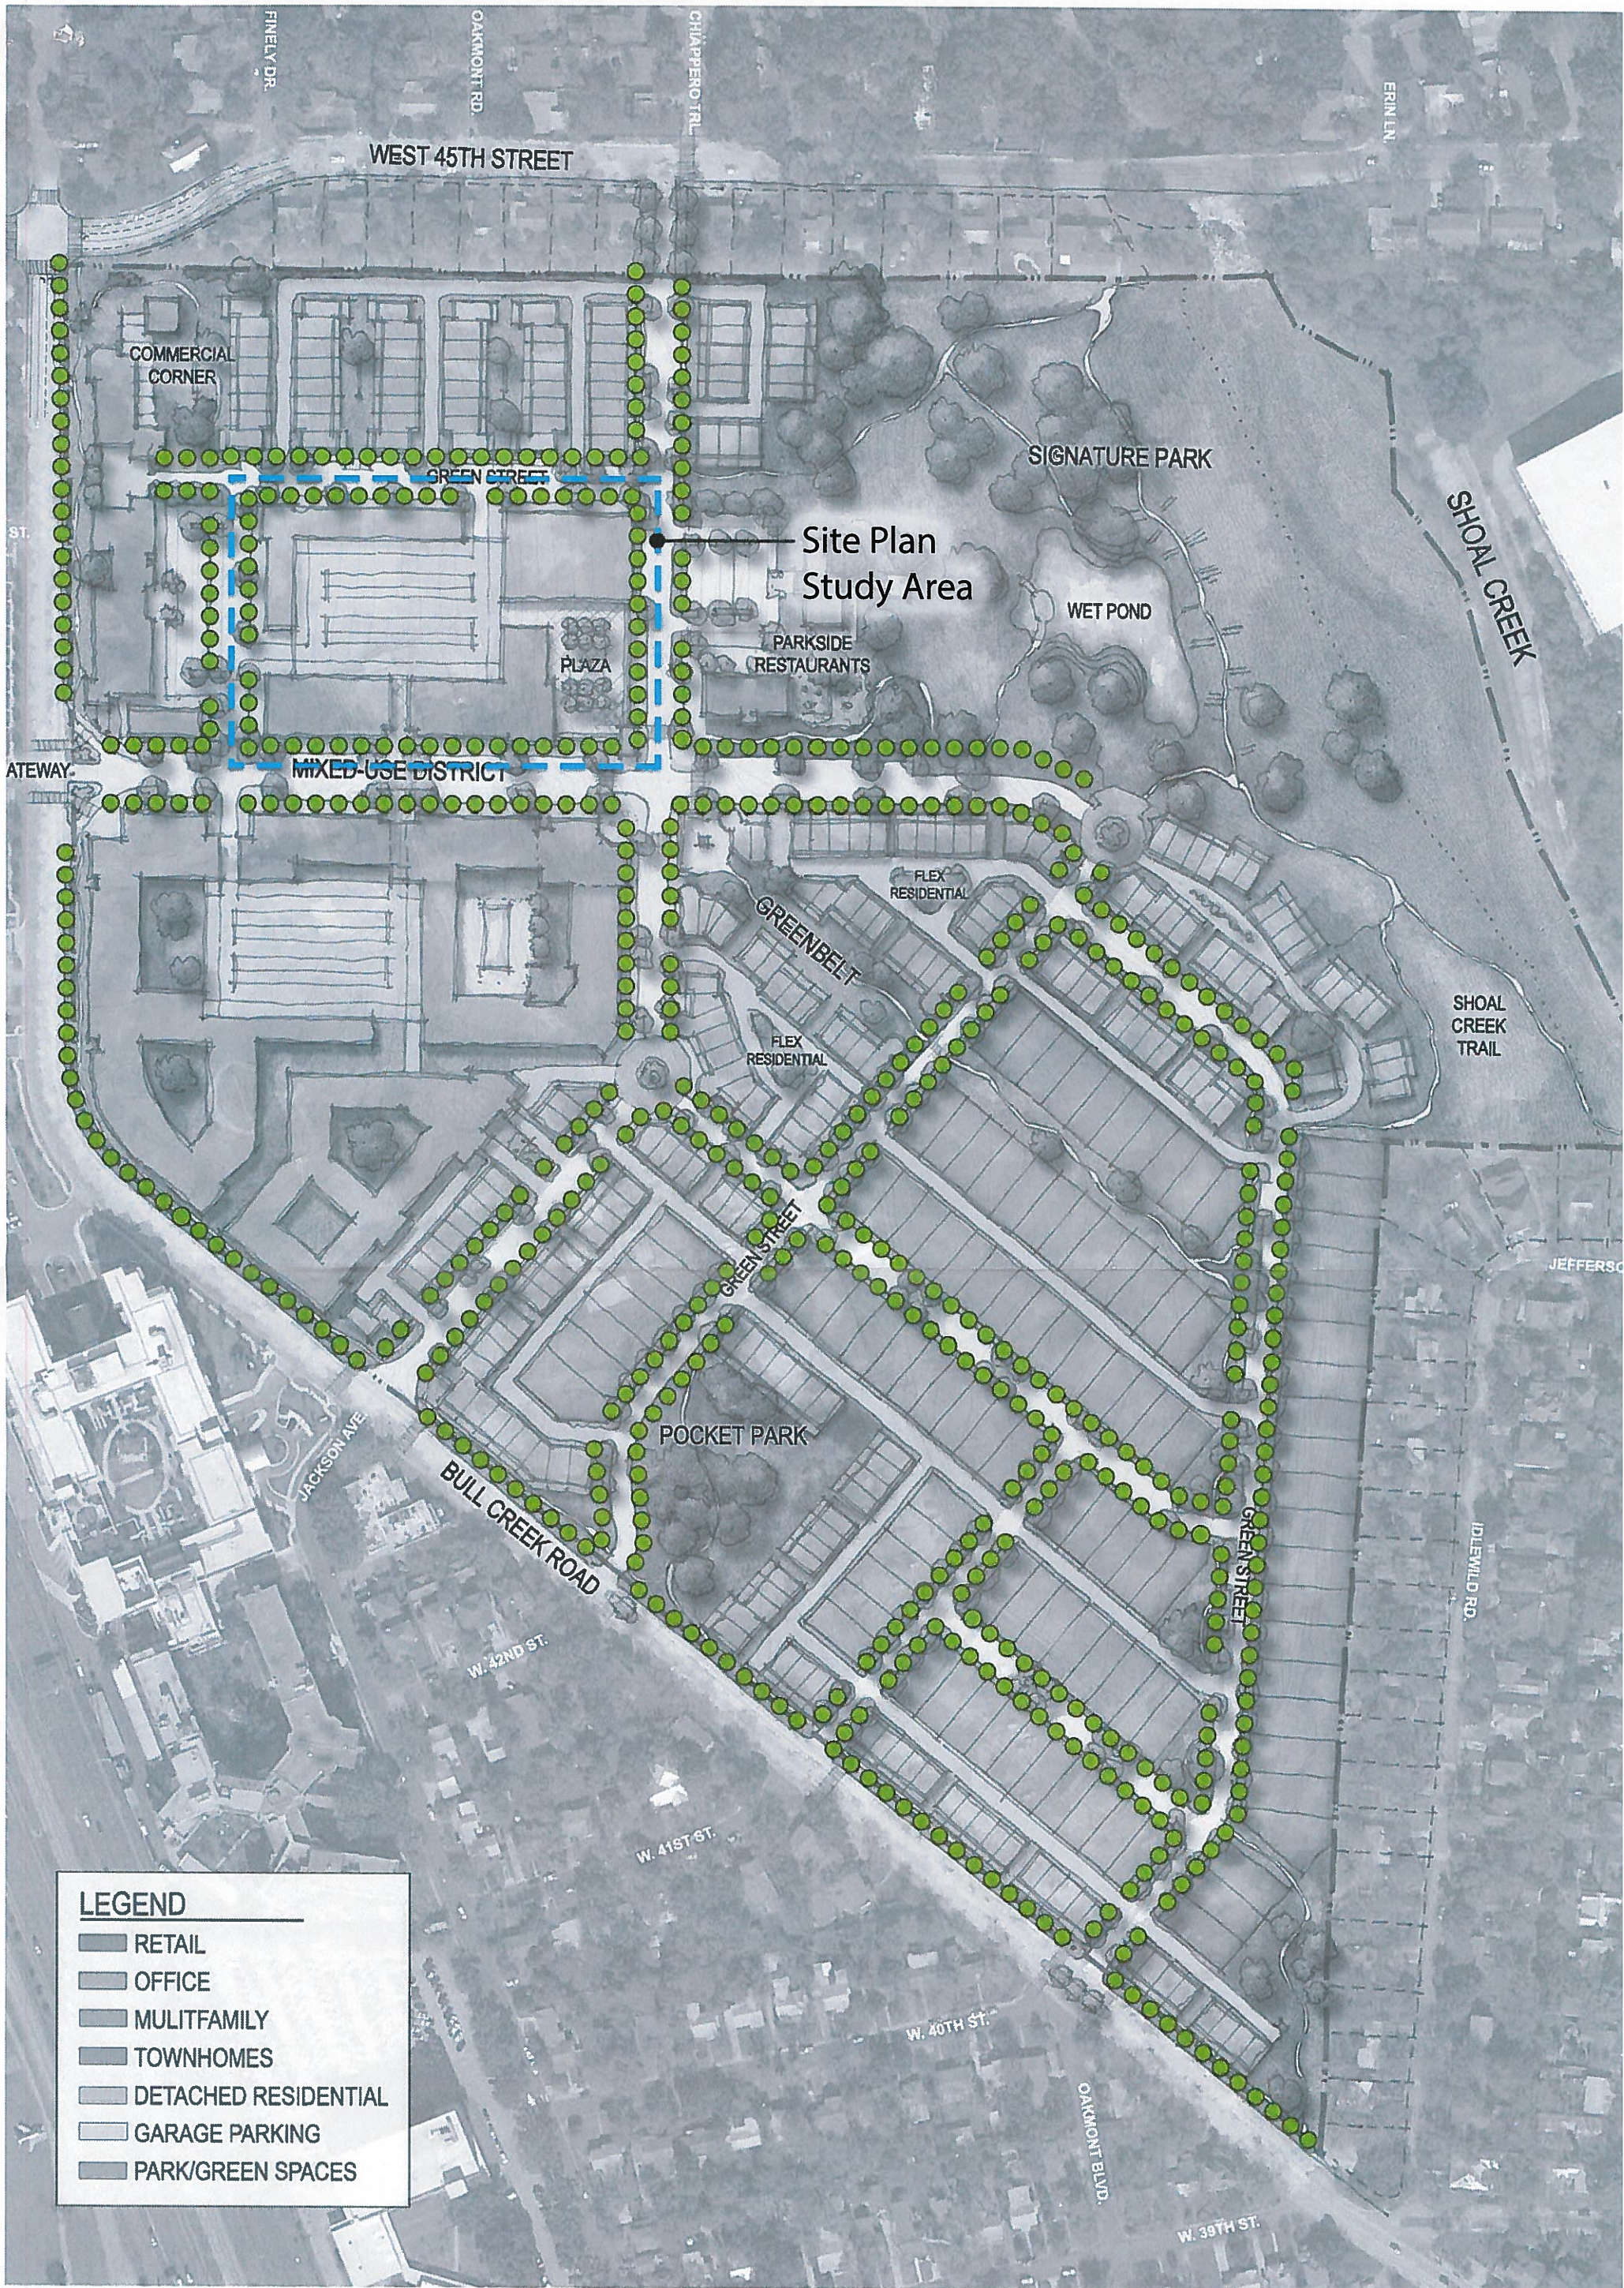
Overall Site Mitigation	Inches	Notes
Mitigation Inches Required	1135	
Mitigation Provided by 3" Street Trees	927	1.5" per tree, 618 trees
Mitigation Provided by 4" Street Trees	1545	2.5" per tree, 618 trees

Site Plan Study	Inches	Notes
Mitigation Inches Required	248	
Mitigation Provided by 4" Street Trees	75	
Mitigation Provided by 6" Street Trees	108	Along retail main street
Total Mitigation Provided by Street Trees	183	
Mitigation Req'd via Additional Trees	65	Plaza, parking bumpouts, courtyards, etc. (approx. 16 additional trees)
