The Grove at Shoal Creek Tree Disposition Plan

Exhibit J

Sheet 1 of 2

THE GROVE AT SHOAL CREEK TREE SURVEY

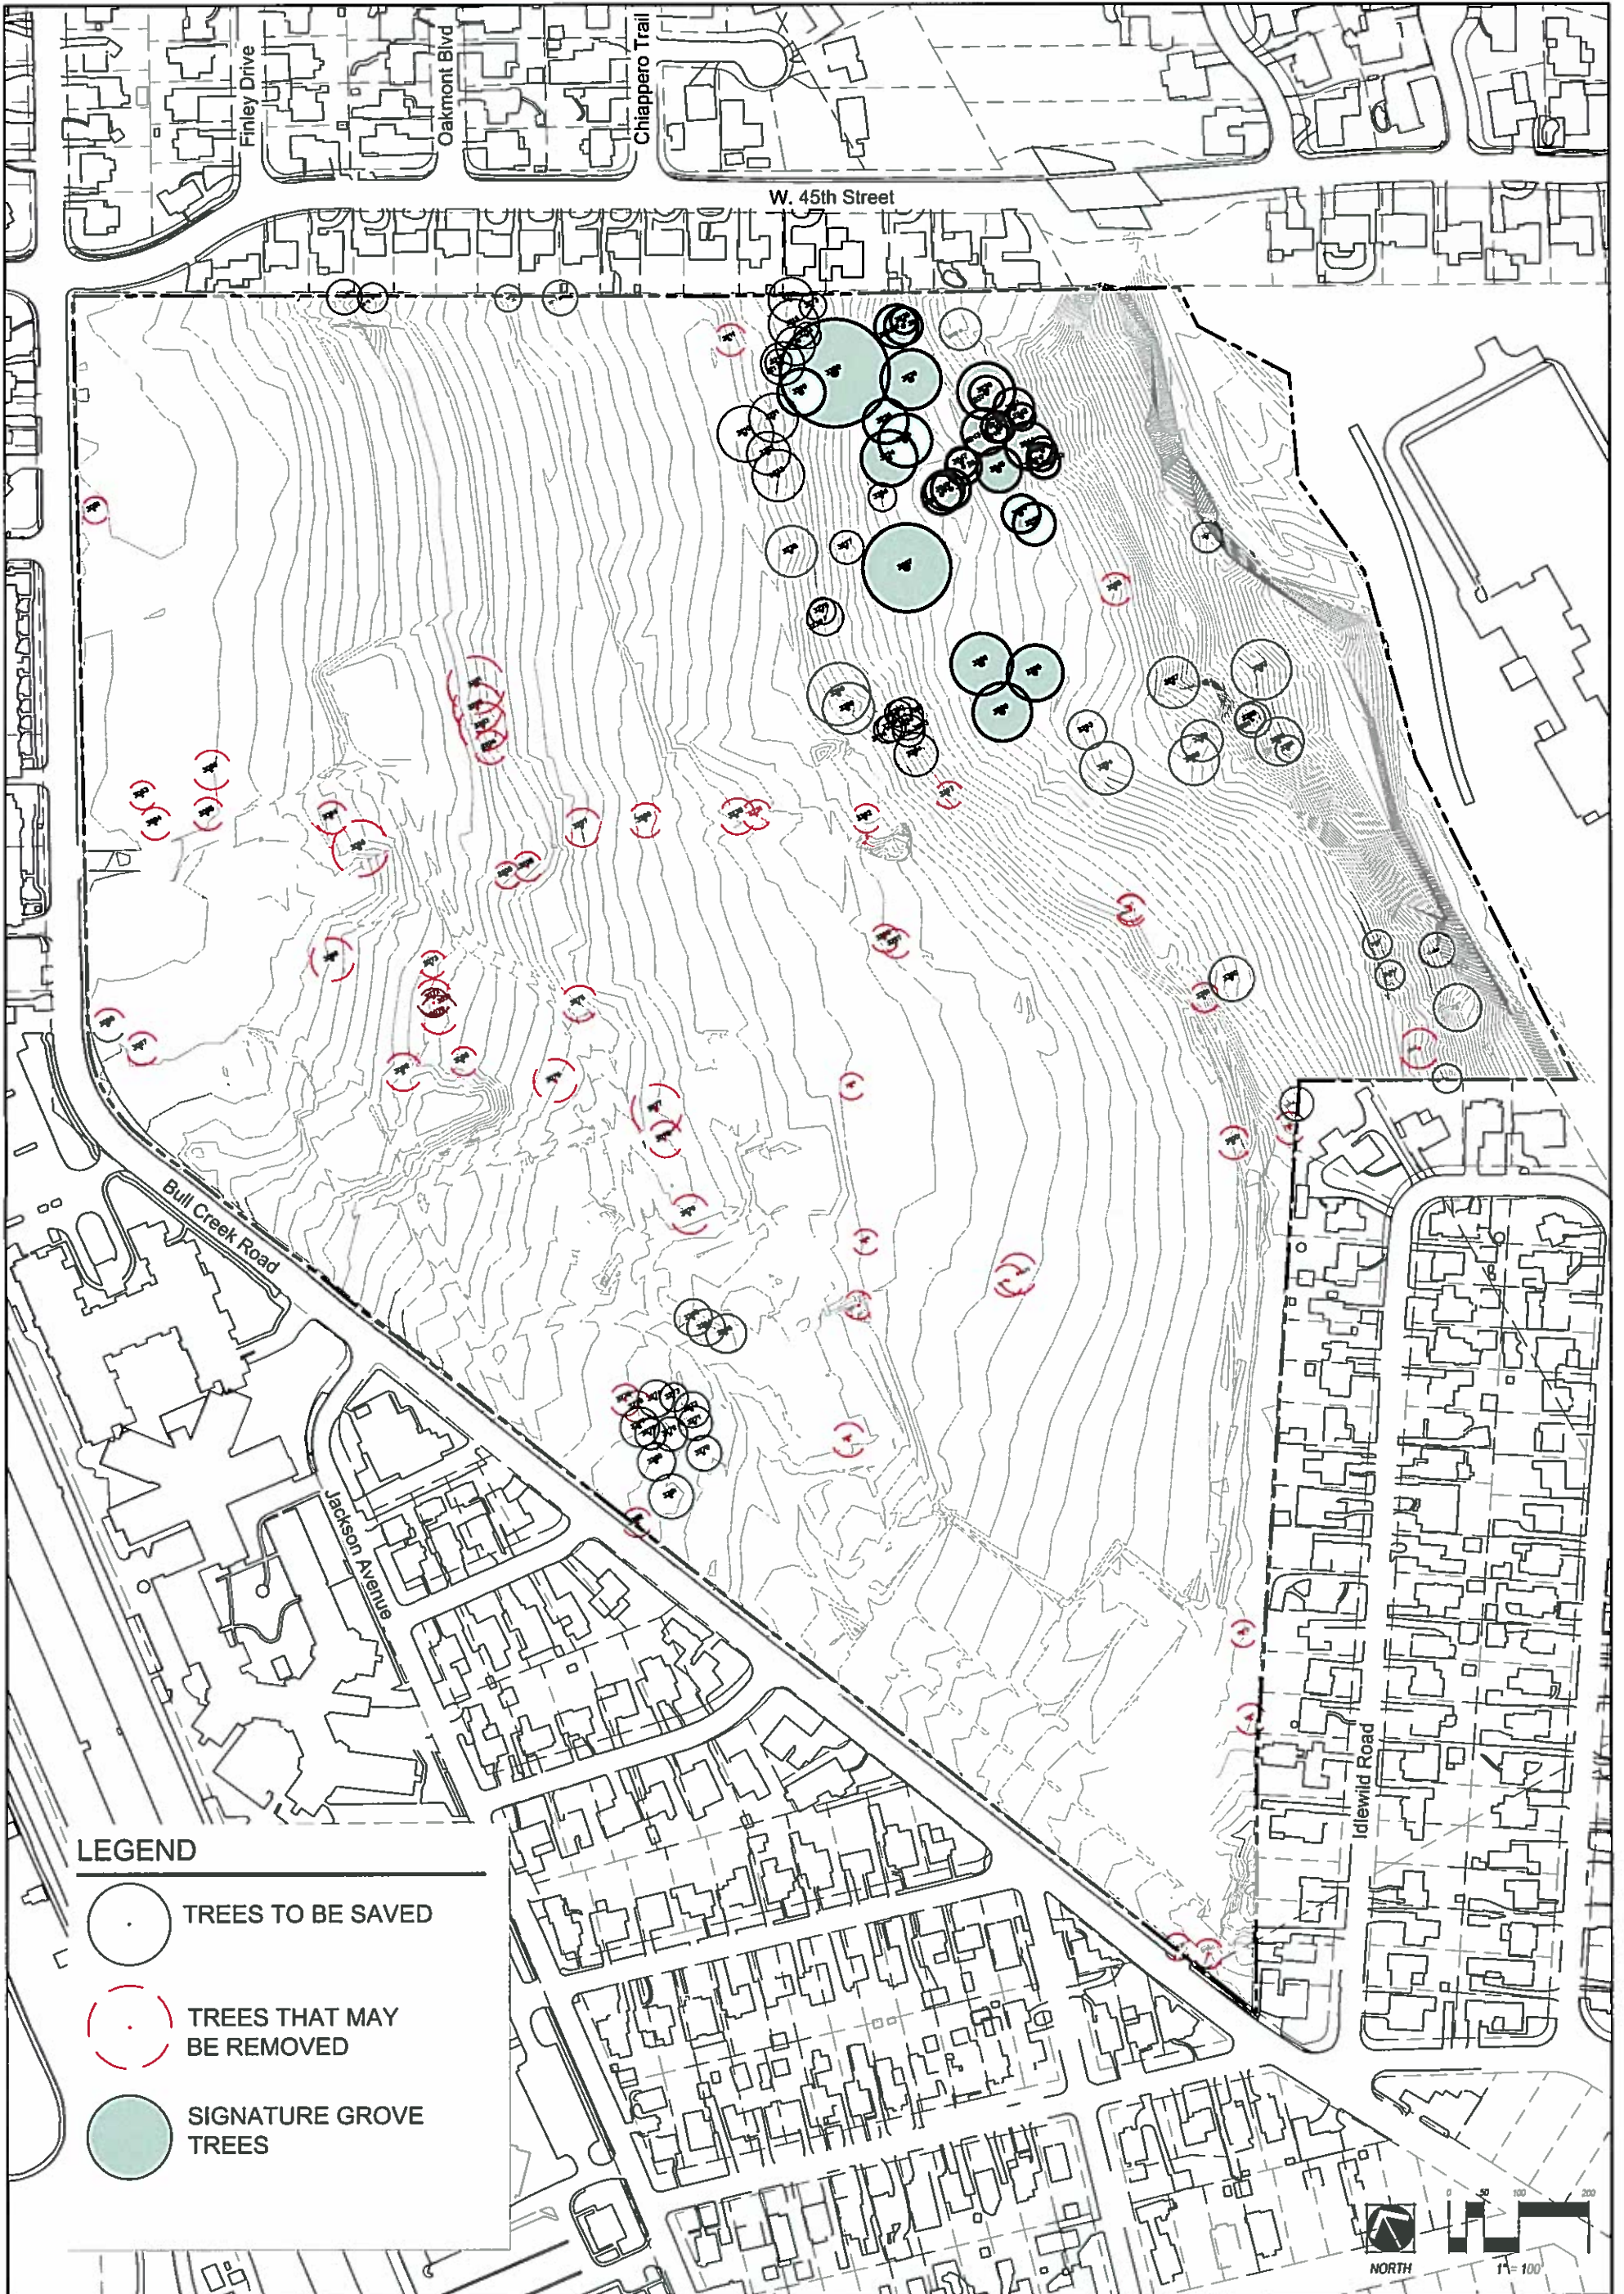
TOTAL APPENDIX F TREE INCHES SURVEYED:	3,561	
TOTAL APPENDIX F TREE INCHES SAVED:	2,744	77% OF TOTAL INCHES SAVED
TOTAL APPENDIX F TREE INCHES MAY BE REMOVED:	837	23% OF TOTAL INCHES SAVED
